*Resources and opportunities to
better manage landslide risk*

Tom Badger

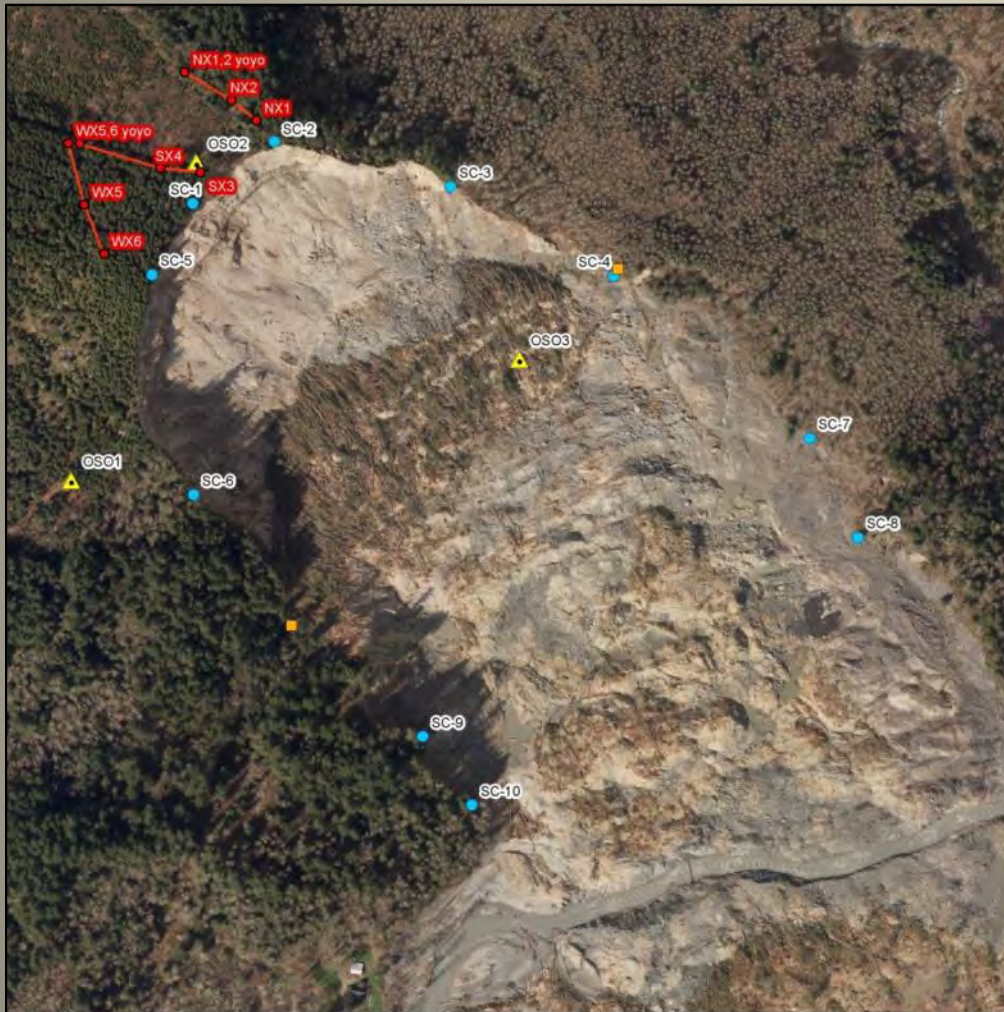
SR530 Slide
 Landslide monitoring sites
 updated 4/14/2014 - 0930 - SLS

Landslide Monitoring

● Extensometer
 ● Engineering lookout
 ● Lake level gage
 ● Scarp ponitoring point
 ● Terrestrial lidar station
 ● USGS Spider

Aerial imagery flown 04/02/2014

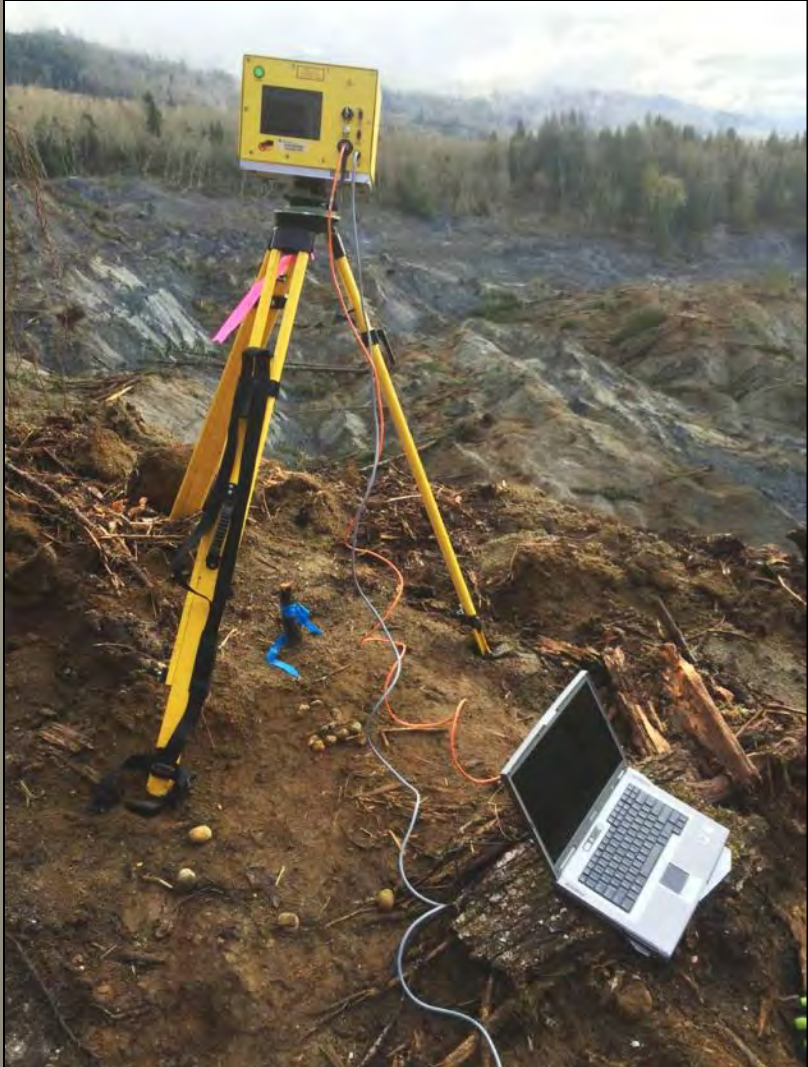
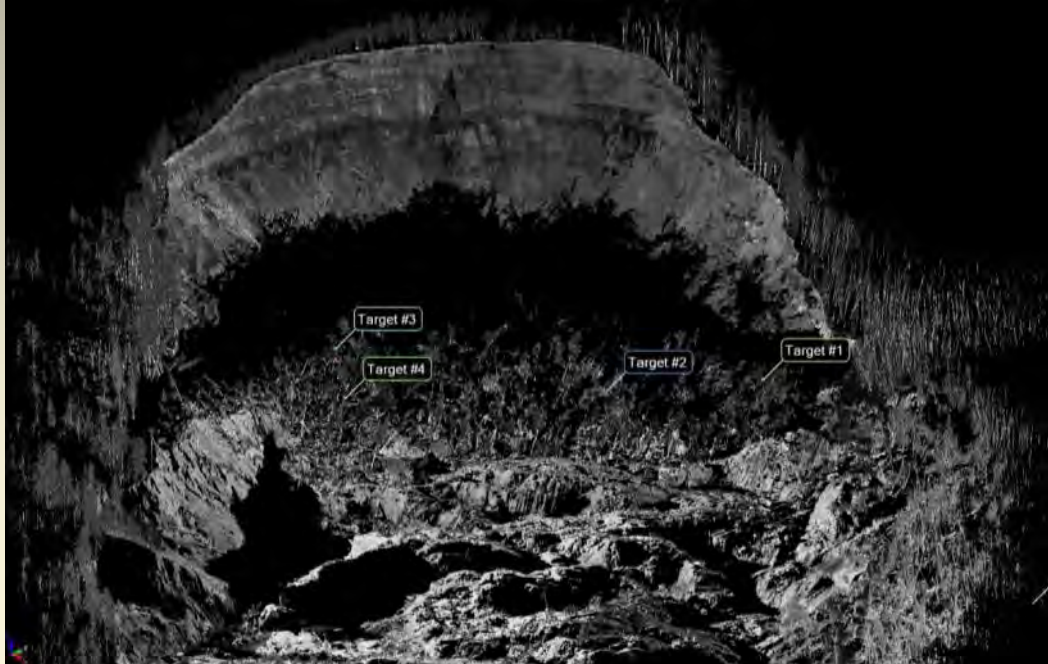
Landslide Monitoring Laser Scanning

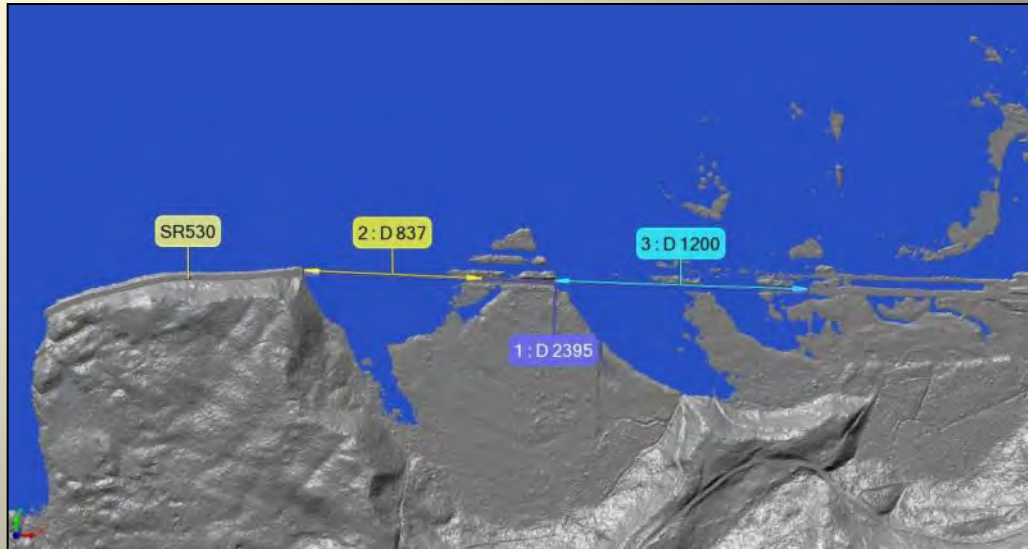
Change Analysis 2003 to 2013

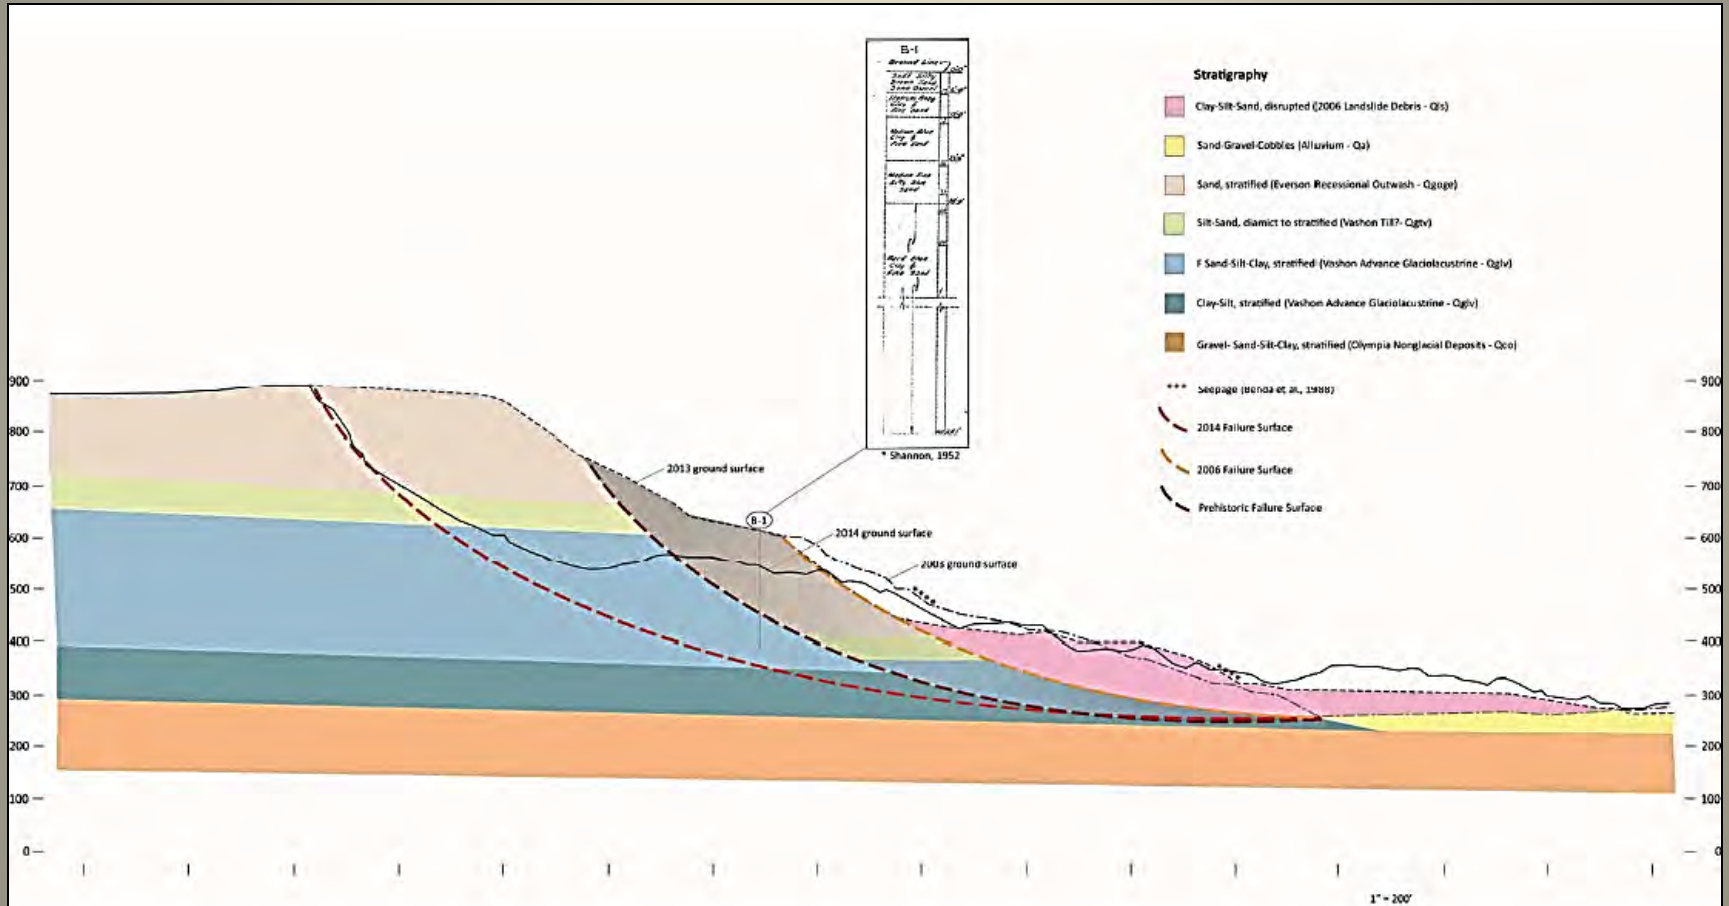
Conceptual Geologic Section

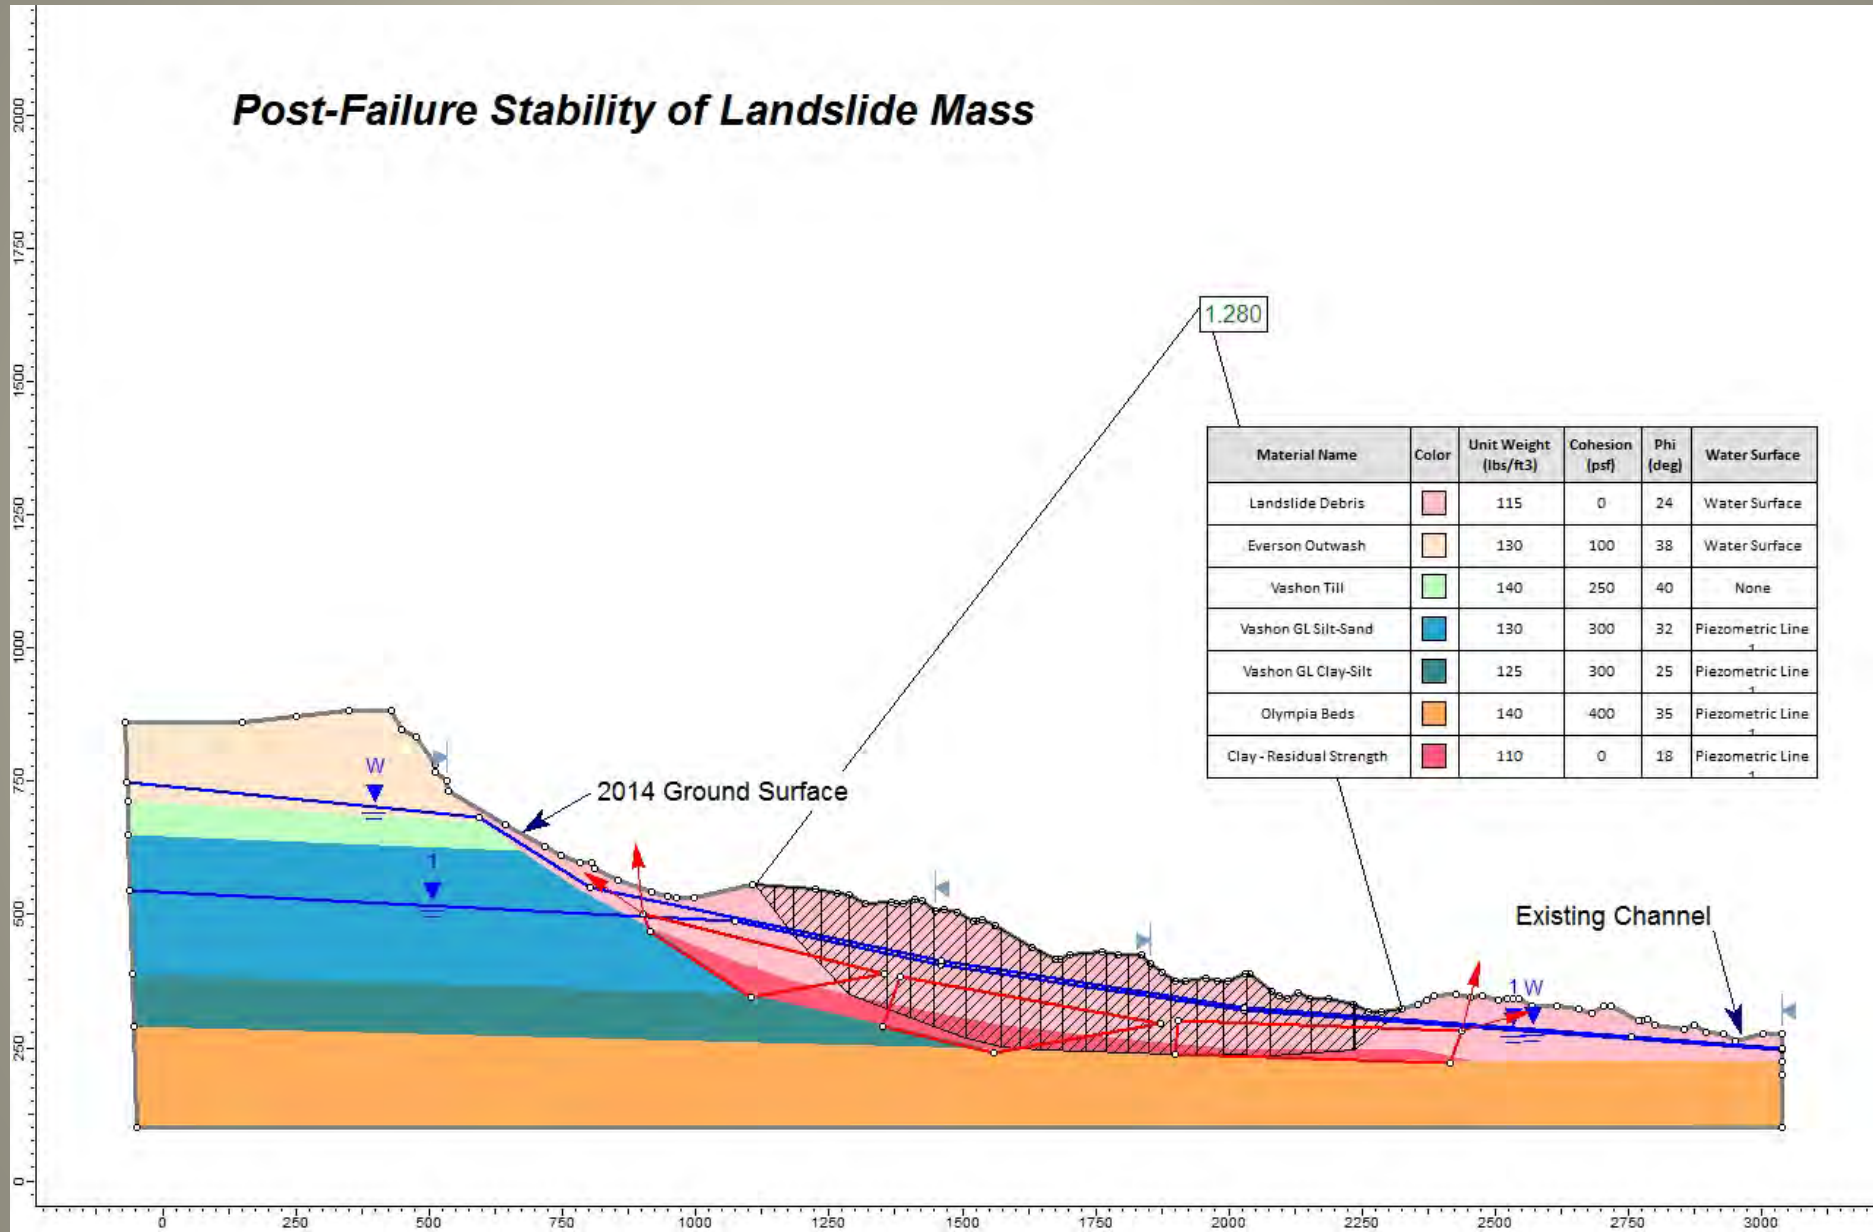
Post-Failure Stability of Landslide Mass
