DIVISION OF GEOLOGY AND EARTH RESOURCES RESPONSE TO THE SR 530 LANDSLIDE

David K. Norman, LHG, LEG
State Geologist

Washington Geological Survey
Division of Geology and Earth Resources
Washington Department of Natural Resources

SR530 LANDSLIDE - MARCH 22, 2014

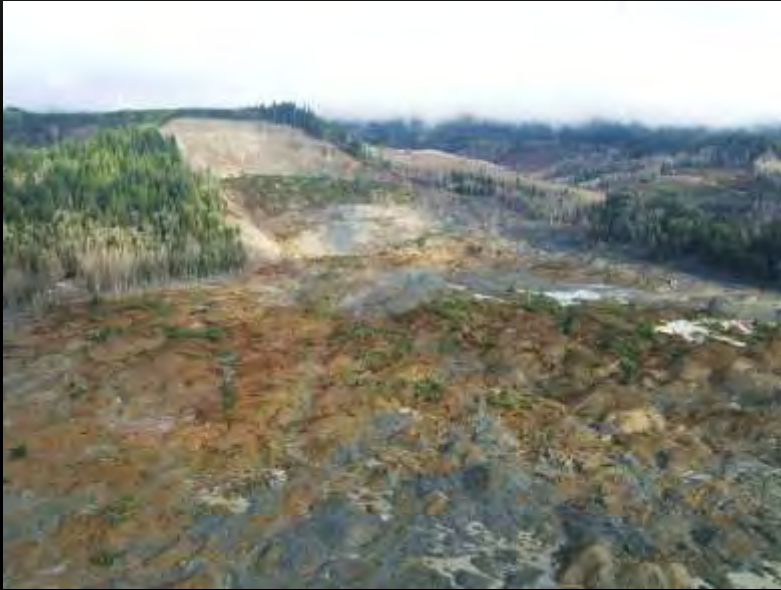
- Speed estimated at 60mph
- < 1 minute to cross valley
- 10 million cy
- Landslide area: 286 acres, 0.45 mi²
 - Flooded area .6 sq. mi.
 - Total impacted area ~ 1 square mile
- Geologists worked under Incident Command System
- Over 900 personnel working at one time
- 28 geologists – County, state, and federal
- >\$120,000,000 spent so far

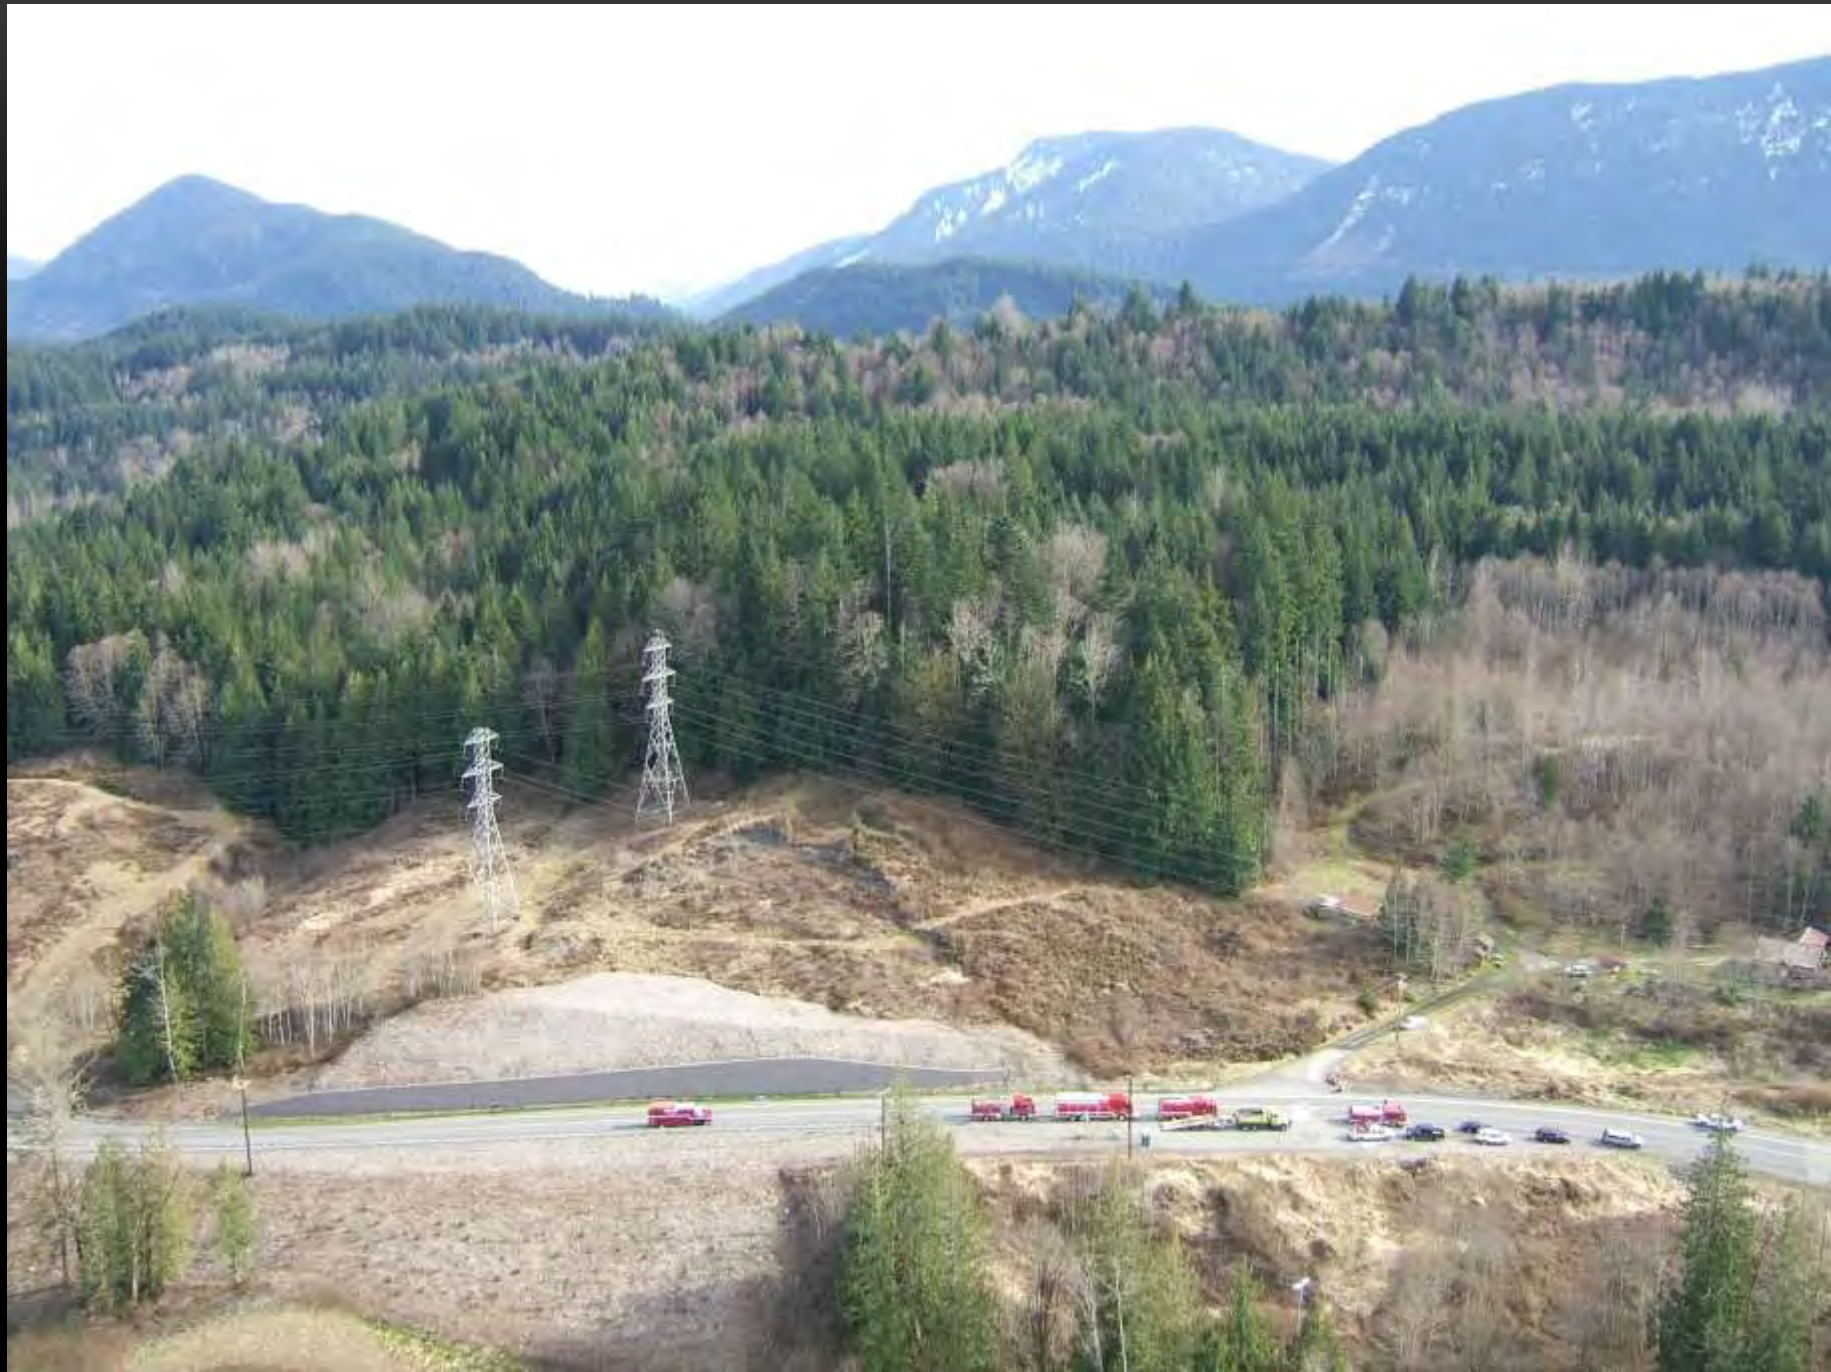
March 23

- Safety implications for the first responders
- Stability of the landslide
- What was happening with the landslide dammed lake and river
- What was happening with other landslides in the valley.

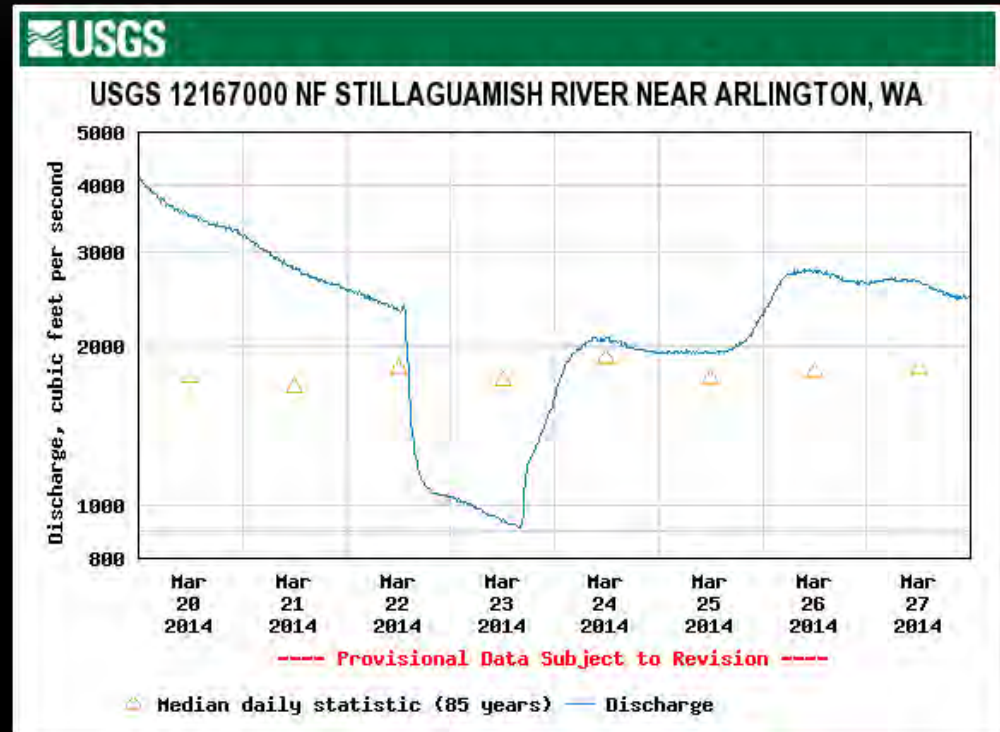
THE STILLAGUAMISH RIVER

- Landslide Blocked the NF Stillaguamish River for a day and half
- Slow incision for an additional day
- Helicopter was the only means to observe the lake

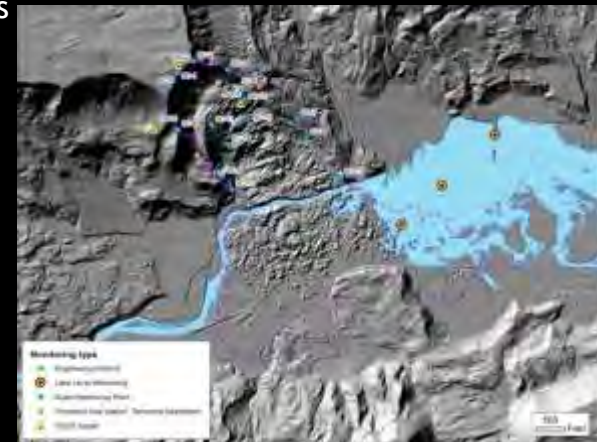
Monitoring

- WGS Coordinated all geologists for the event to ensure safety of the search and rescue workers
- Geologists were critical in providing GIS data that assisted directly with response efforts
- Continuous instrumentation provided
 - 3 USGS spiders (continuous GPS and seismometers)
 - 3 WSDOT extensimeters
 - 3 USGS lake level gages
- Daily, when personnel working on debris field
 - 15 survey reflectors
 - Daily meetings on landslide, river, and lake
 - 2 WGS geologists as lookouts with direct contact to Branch Chiefs
- Other
 - WSDOT terrestrial lidar
 - 2 DEM lidar flights
 - 3 aerial imagery flights
